Building Number: 107
(Same as 101, 103, 105 and 109)

Original Name: Family Housing (large)

**TABLE 1. • List Of Materials Testing Positive For Asbestos
Building 107, Truro Air Base, North Truro, Massachusetts**

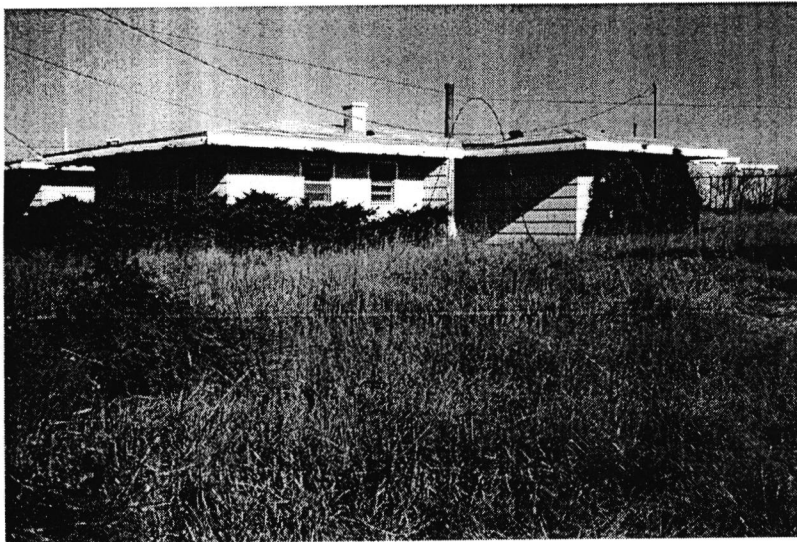
View from southwest.

Low-pitch hip roof covered with roll asphalt in **fair condition**. Possible leak at vents. Deep overhangs; paint at wood soffit is peeling / cracking.

Wood frame sheathed in cement asbestos shingles. 4 painted wood flush doors. 3 are entrances to building; one to the "closet" that houses the elec. panel. 8 double-hung and one picture window - all painted wood with aluminum storm windows. All paint is peeling / cracking.

Painted wood window and door trim and wood fascia in **poor condition**. Door trim at the vestibule on the east wall is rotted. All paint is peeling / cracking.
